MILL VALLEY SCHOOL DISTRICT FACILITIES ASSESSMENT 2018

MILL VALLEY SCHOOL DISTRICT PRE-PLANNING SURVEY

**EDNA MAGUIRE ELEMENTARY: PRE-PLANNING SURVEY**

# **FACILITY CONDITION ASSESSMENT**

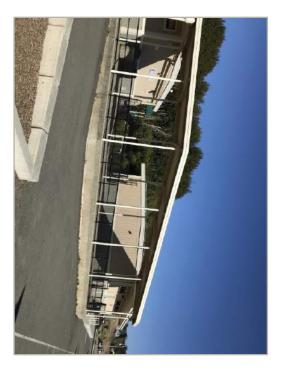
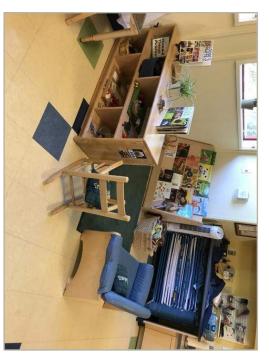
## 8. Portables- Marin Day Schools Summary

Portables- Marin Day Schools Information	
HVAC	Individual furnace units	Fair
Fire Suppression	Wet-pipe sprinkler system; hydrants, fire extinguishers	Fair
Electrical	Source and Distribution: Main panel with copper wiring Interior Lighting: LED, Emergency: None	1.1.1.1.1.1
Fire Alarm	Alarm panel, smoke detectors, alarms, strobes, pull stations, back-up emergency lights, and exit signs	Fair
Equipment/Special	None	:
Key Issues and Findings	No air conditioning, only one furnace was seen, there are likely more. heaters were observed.	more. No water

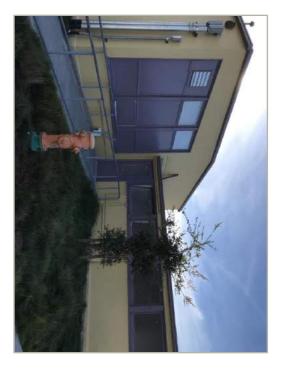
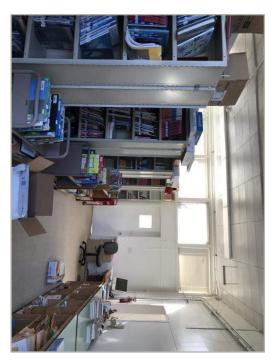
# 10. Maintenance Offices/Taikwondo Summary

Key Issues and Findings	Equipment/Special	Fire Alarm	Electrical	Fire Suppression	HVAC	
The exterior wooden doors and windows are deteriorating. Within a year is scheduled to be coated with a badly needed elastomeric coating.	None	Alarm panel, smoke detectors, alarms, strobes, pull stations, back-up emergency lights, and exit signs	Source and Distribution: Main switchboard with copper wiring Interior Lighting: T-5, LED, Emergency: None	Fire extinguishers, hose cabinets	Individual furnace units	Maintenance Offices / Taekwondo Information
a year, the roof	;	Fair	Fair	Fair	Good

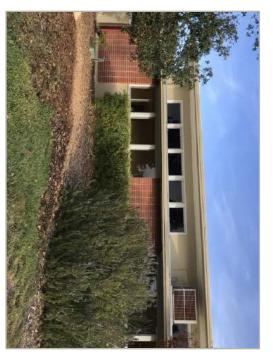
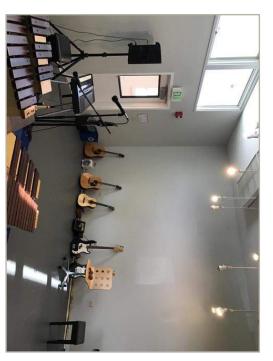
# Pacific Discovery School Summary

Plumbing Copp Unab	Elevators None	Interiors Walls Floor Ceilin	Roof	Façade	Structure Conv	System Desc	Number of Stories One	Building Size 15,000 SF	Constructed/ 1947 Renovated	Address 80 Lc	
Copper supply and cast iron waste and venting Unable to locate water heater		Walls: Painted gypsum board and plaster Floors: Carpet, VCT, ceramic tile Ceilings: Painted gypsum board, ACT	Primary: Flat construction with modified bituminous finish	Stucco with f wood and aluminum windows	Conventional wood frame structure on concrete slab	Description		0 SF		80 Lomita Drive, Mill Valley, California	Pacific Discovery School Information
Fair	1	Fair	Fair	Poor	Fair	Condition
