MILL VALLEY SCHOOL DISTRICT FACILITIES ASSESSMENT 2018

MILL VALLEY SCHOOL DISTRICT PRE-PLANNING SURVEY

**EDNA MAGUIRE ELEMENTARY: PRE-PLANNING SURVEY**

# **FACILITY CONDITION ASSESSMENT**

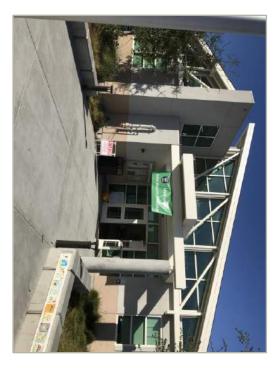
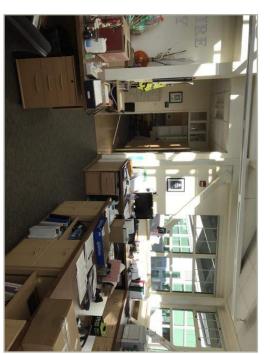
## 2 Building A (Administration) Summary

None	Key Issues and Findings
	None	Equipment/Special
Excellent	Alarm panel, smoke detectors, alarms, strobes, pull stations, back-up emergency lights, and exit signs	Fire Alarm
	Source and Distribution: Main switchboard with copper wiring Interior Lighting: LED Emergency: Inverter for lights	Electrical
	Wet-pipe sprinkler system; hydrants, fire extinguishers	Fire Suppression
	Individual heat pump units Supplemental components Ductless split-systems	HVAC
	Building A (Administration) Information

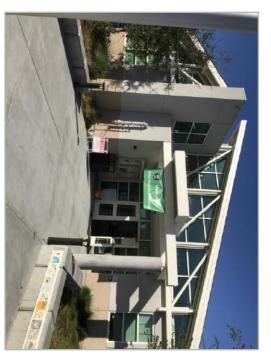
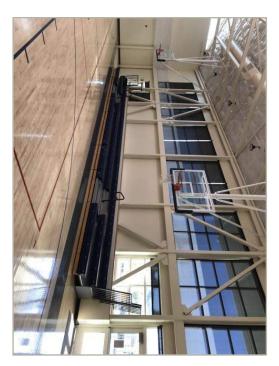
## <u>ယ</u> Building B (Multi Purpose **Building) Summary**

Plumbing Cop Elec	Elevators Who	Interiors Wal Floc Ceil	Roof Prin Sec	Façade Stu	Structure Stee	System Des	Number of Stories One	Building Size 16,4	Constructed/ 2014 Renovated	Address 80 L	
Copper supply and cast iron waste and venting Electric water heater	Wheelchair lift	Walls: Painted gypsum board, sound board and vinyl wall covering Floors: Carpet, sheet vinyl, maple sports floor Ceilings: Painted gypsum board, ACT	Primary: Gable construction with asphalt shingles Secondary: Flat construction with single-ply TPO/PVC membrane	Stucco with aluminum windows	Steel frame on a concrete slab	Description		16,400 SF	4	80 Lomita Drive, Mill Valley, California	Building B MPR Information
Good	Good	Good	Good	Good	Excellent	Condition

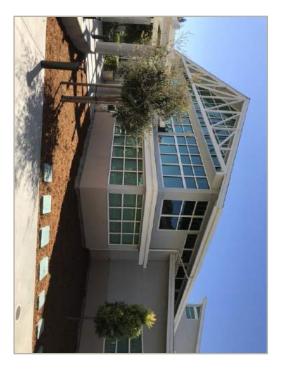
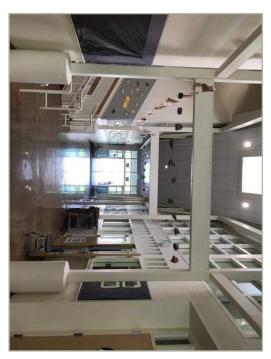
# 4. Building C Library Summary

Key Issues and Findings	Equipment/Special	Fire Alarm	Electrical	Fire Suppression	HVAC	
No air conditioning	None	Alarm panel, smoke detectors, alarms, strobes, pull stations, back-up emergency lights, and exit signs	Source and Distribution: Main panel with copper wiring Interior Lighting: LED Emergency: Emergency light inverter	Wet-pipe sprinkler system; hydrants, fire extinguishers	Individual furnace units	Building C, Library Information
	i	Good	Good	Good	Good

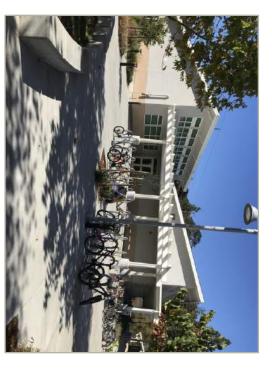
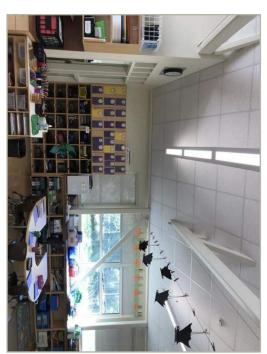
## 5. Building D, Kindergarten Summary

Key Issues and No air conditioning Findings	Equipment/Special None	Fire Alarm Alarm panel, smoke detectors, a emergency lights, and exit signs	Electrical Source and Distributi Interior Lighting: LED Emergency: Emerger	Fire Suppression Wet-pipe sprink	HVAC Individual furnace units	Plumbing Copper supply and ca Electric water heaters
ng		Alarm panel, smoke detectors, alarms, strobes, pull stations, back-up emergency lights, and exit signs	Source and Distribution: Main panel with copper wiring Interior Lighting: LED Emergency: Emergency light inverter	Wet-pipe sprinkler system; hydrants, fire extinguishers	e units	Copper supply and cast iron waste and venting Electric water heaters
	;	Good	Good	Good	Good	Good
